Manhole Inspection Summary

Manhole # S41W__019MH

Insp Date: **10/10/08 1:37 PM**

Location Address: **1500 key hw.**

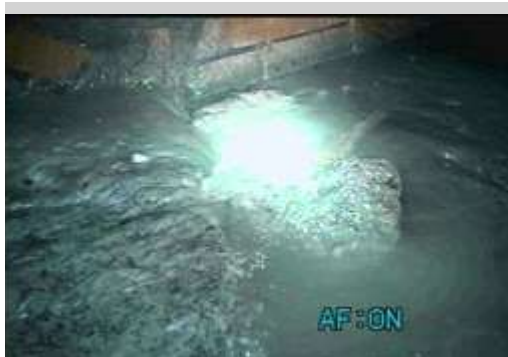
Defect 5

☒ **Debris**

channel debris

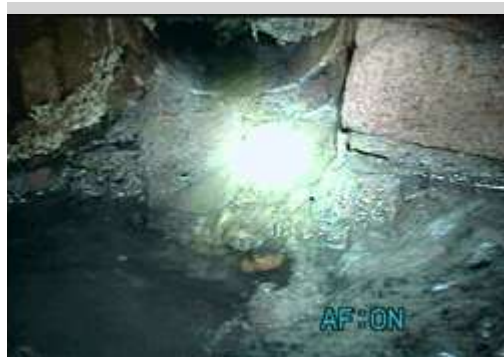
Defect 6

☒ **Cracked**

☒ **Deteriorated**

☒ **Leaks**

channel cracked, deteriorated & leaking
(through an apparent hole in channel)

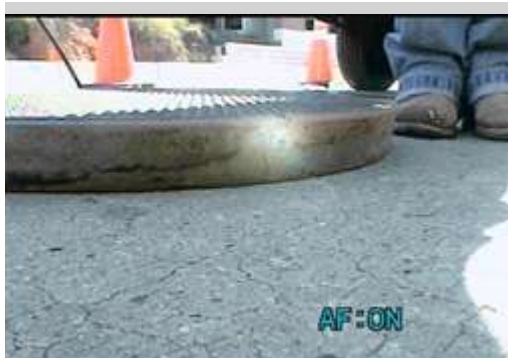
Defect 4

Condition: **Cracked**

cracked cover

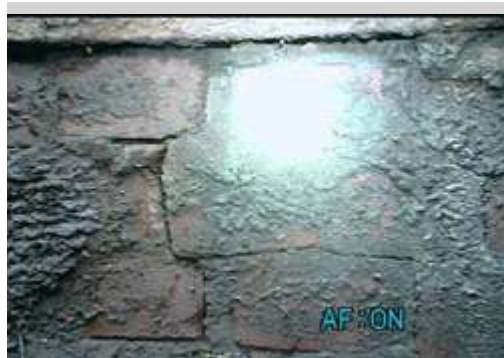
Defect 3

☒ **Cracked**

☒ **Deteriorated**

☒ **Wall**

cracked and deteriorating chimney/frame adj,
chimney wall infiltration

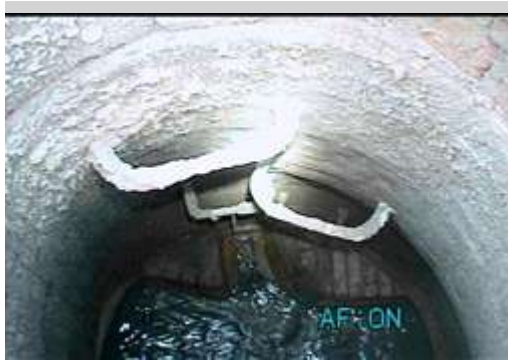
Defect 2

☒ **Corroded**

cor. steps

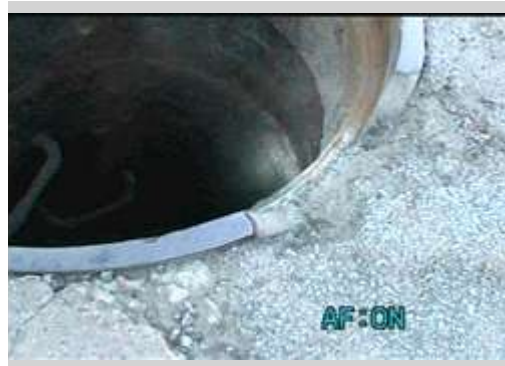
Defect 1

☒ **Cracked**

cracked frame

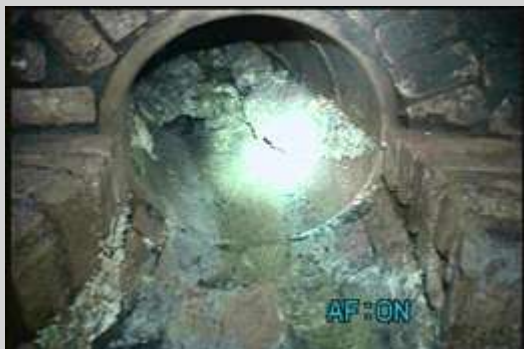
3 O'Clock Inflow

Deposits: ☐ None ☐ Mud ☐ Sludge ☒ **Debris** ☐ Grease

Silt Depth: 4 (in.) Deposits Extent: **Medium**
